Ancient Machu Picchu Drainage Engineering

ABSTRACT: The drainage infrastructure constructed by the Inca at ancient Machu Picchu represents a significant public works achievement. The difficult site constraints associated with the nearly 2,000 mm per year of rainfall, steep slopes, landslides, and inaccessibility posed drainage challenges that were met successfully by the Inca. The technical analysis of the Inca drainage works demonstrates that the drainage criteria used were reasonable and the implementation exceptional, and that the Inca were good engineers even though they labored without the benefit of a written language or the use of a wheel. Proof of the Inca success with drainage rests with the fact that Machu Picchu lay in the rainforest for 400 years without failure. There is no better example of successful ancient civil engineering than Machu Picchu. It was built by Native Americans before the arrival of the Spanish Conquistadors, was essentially abandoned in 1540 A.D., and endured for 4 1/2 centuries under a thick rainforest until the 20th century. Scientists, engineers, and laymen alike continue to marvel at the wonders of Machu Picchu.

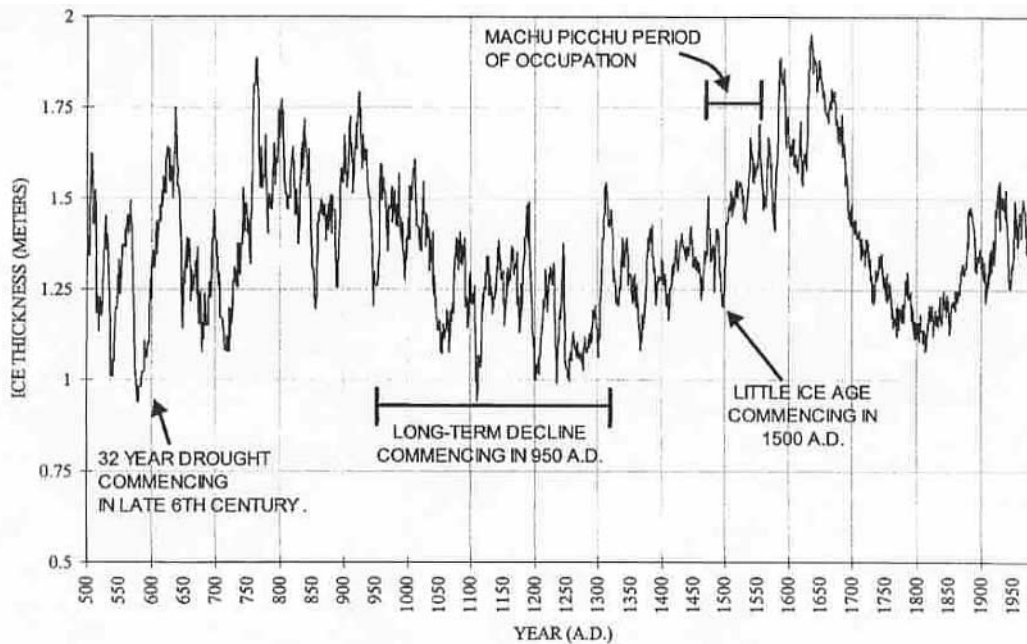
Figure 3. Long-Term 10-Year Running Average of Precipitation Based on Quelccaya Ice Cap Cores by Byrd Polar Research Center at Ohio State University. Machu Picchu Primary Occupation Period Is Shown from 1450 to 1540 AD.

When viewing the complex but orderly layout of the ruins, scientists and laymen alike express wonder and ask questions about the drainage and potential irrigation of the numerous agricultural terraces. Because the annual average precipitation likely was about 1,940 mm per year at the time of occupation, there was no need to irrigate agricultural land at Machu Picchu, and field investigations by the writers indicated that no irrigation delivery or distribution system existed [Wright et al. 1997(c)]. Fig. 3 presents the ice core data from the Quelccaya ice cap, representing long-term precipitation patterns (Thompson et al. 1992; Thompson and Moseley-Thompson 1989). The Machu Picchu period is shown for comparison.

470 to 1984 as shown in Fig. 3 (Thompson et al. 1984). The long-term (470 through 1984) average annual ice layer thickness for the two ice cores is about 1.4 m, estimated to represent 1,990 mm of annual precipitation.

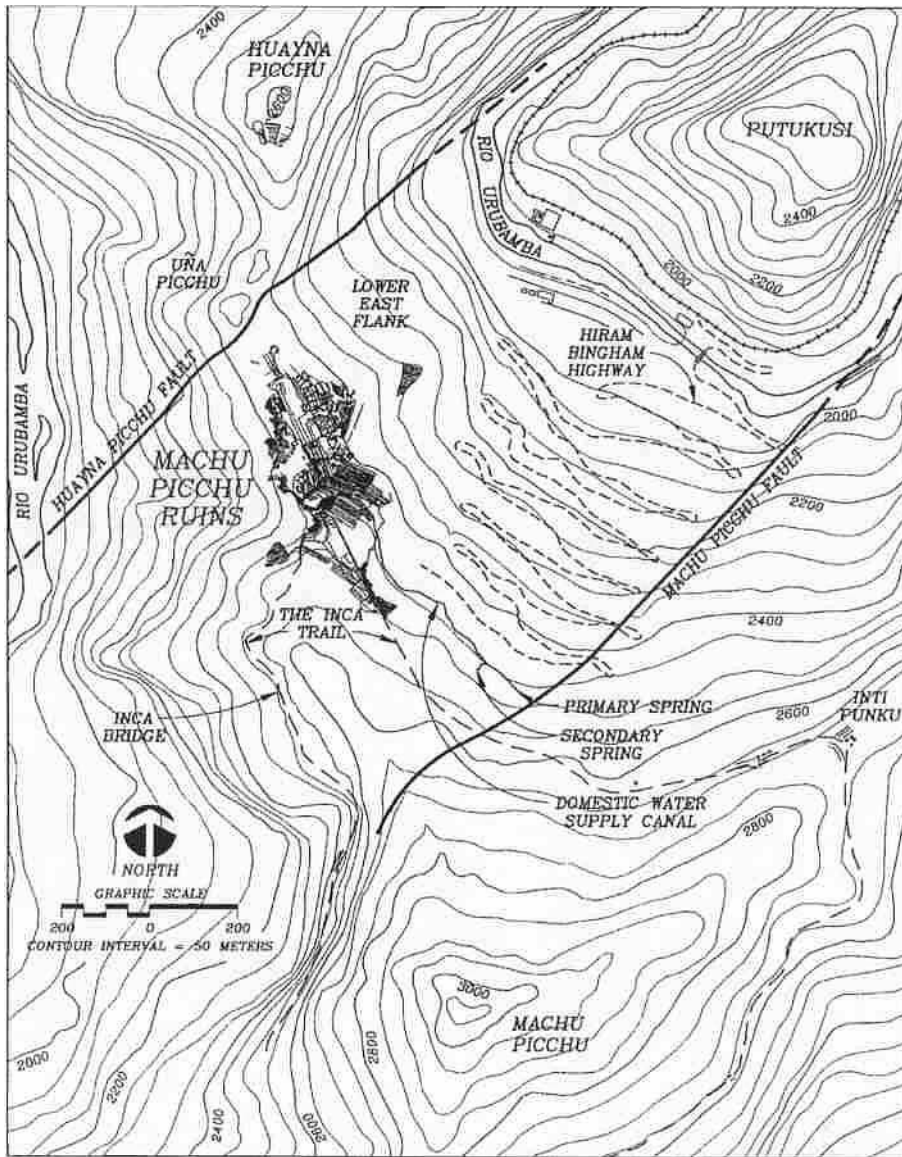
Figure 4. Machu Picchu and Environs, Showing Two Main Geologic Faults Associated with Machu Picchu, and Two Bordering Mountains of Huayna Picchu and Machu Picchu. Across River Is Mountain of Putucusi.

The Inca royal estate of Machu Picchu is situated on a high mountain ridge between two prominent peaks at an elevation of 2,438 m (Fig. 4). The ridge plunges precipitously on both sides some 450 m to the Urubamba River. It would appear to be an unlikely location for ancient peoples to have been able to construct a complex of beautiful buildings that would endure for so long a time.

The most significant geologic characteristics of the Machu Picchu site are the numerous faults and abundant rock fractures. Two principal faults are named for the two prominent local peaks: Huayna Picchu Fault and Machu Picchu Fault, as shown in Fig. 4. These high-angle reverse faults formed a wedge-shaped structural block relative to their namesakes. This block, or graben, is the structure on which the ancient Inca people built their city. The

The Machu Picchu fault system is also responsible for much of the topographic relief in the vicinity of the mountain sanctuary. The orientation of the fault system can be identified by aligning the near-vertical northwestern face of Machu Picchu with the linear reaches of the nearby Urubamba River along the southeastern flank of Putucusi (Fig. 4).

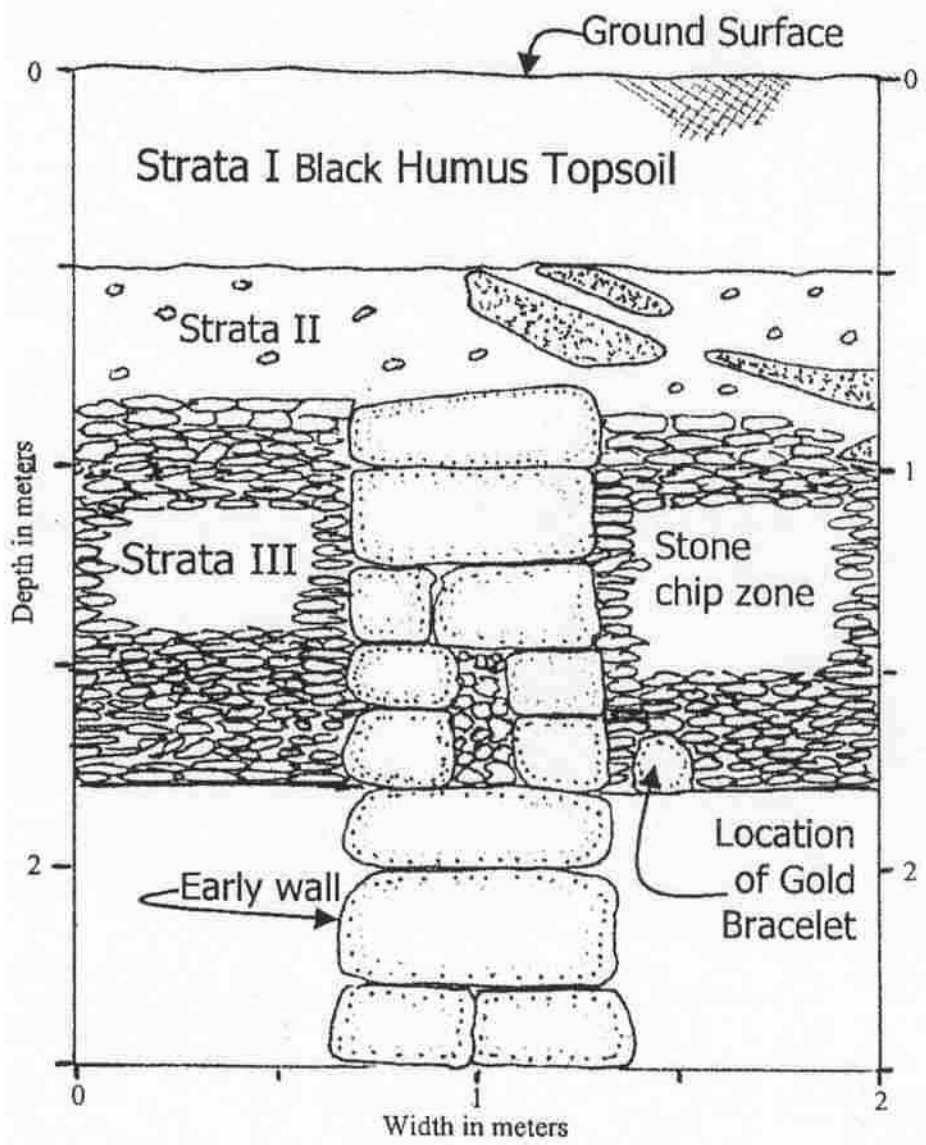
Figure 6. Test Pit in Plaza Area Showing Soil Profile, Sand Lenses, Early Wall, Stone Chip Drainage Zone, and Location of First and Only Gold found at Machu Picchu.

5. Urban and agricultural drainage channels combined with stairways, walkways, or even temple interiors.
6. Deep subsurface strata under plazas of rock chips and stones (Fig. 6) to allow the plazas to receive and infiltrate runoff from tributary areas.

1. An ancient buried stone wall, which either represented an early (1450 A.D.) change in construction plans or a temporary retaining wall for construction purposes (Fig.6).
2. A subsurface layer of loose rock and stone chips at depth for underground drainage. The rock chips found in the plaza represented a portion of the recycling of the thousands of cubic meters of waste chips from the stonecutters.
3. A gold bracelet that had been carefully placed at the foot of the buried stone wall between two guard rocks, perhaps as an offering to Pachamama (Earth Mother).

The subsurface chipped rock stratum was about 1 m thick with an estimated coefficient of permeability of about 160 m/day and detention capacity of about 150 L/m³. As a result, the deep percolation from a major rainfall event could be temporarily stored in the subsurface chipped rock stratum and slowly released to the downstream subsurface discharge point at a modest rate without causing a high groundwater table, which otherwise would have led to instability of the plaza and its soils.

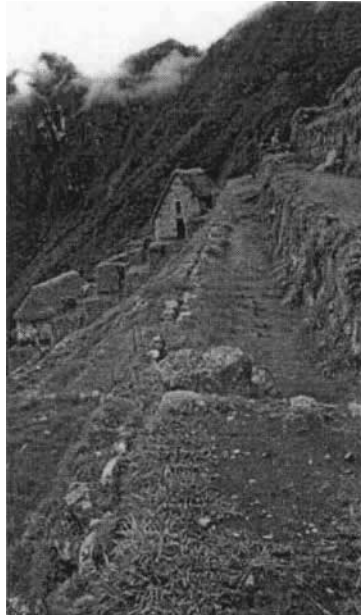
Figure 7. Canal with Qolqas (Storehouses) and Terraces in Agricultural Sector. Water Supply Canal and Agricultural Terraces Were Found in Good Condition by Bingham in 1911, Attesting to Excellent Engineering of Ancient Incas.

The excavations and laboratory test results show that the topsoil was typically 0.5 m thick, and that even at greater than 1 m deep, the subsoil of the deeper strata contained topsoil characteristics. Fortunately, the discovery of a gold bracelet in Test Pit No. 6 justified additional archaeological excavations by the INC scientists during 1996. The subsequent and more extensive excavations have shown a deep subdrainage system, representing the work of a well-organized and committed corporate agricultural society having knowledge of the importance of good drainage of soil for sustained agricultural production and foundation stability (Fig. 6). Fig. 7 shows the stability of the agricultural terraces that supported the domestic water supply canal.

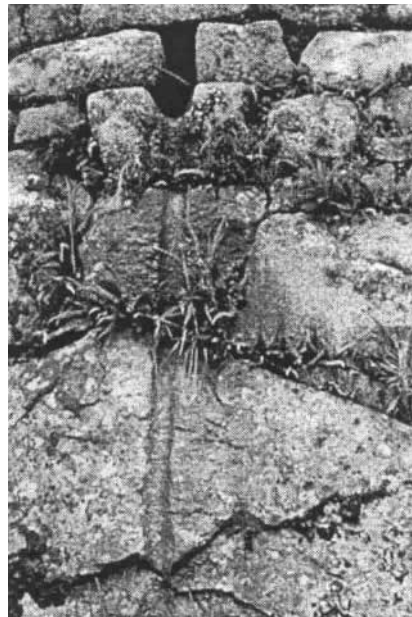
Figure 10. Engineers Strategically Placed 129 Surface Drainage Outlets in Walls to Drain Interior Ground Surfaces. This Drainage Outlet Was Fitted with Vertical Channel to Avoid Splash.

7. A well-conceived and strategically placed urban area system of 129 drain outlets placed in the numerous stone retaining and building walls (Fig. 10).
8. Subterranean caves strategically used for drainage discharge, with relatively free subsurface flow via natural underlying permeable deposits of granite rock falls.

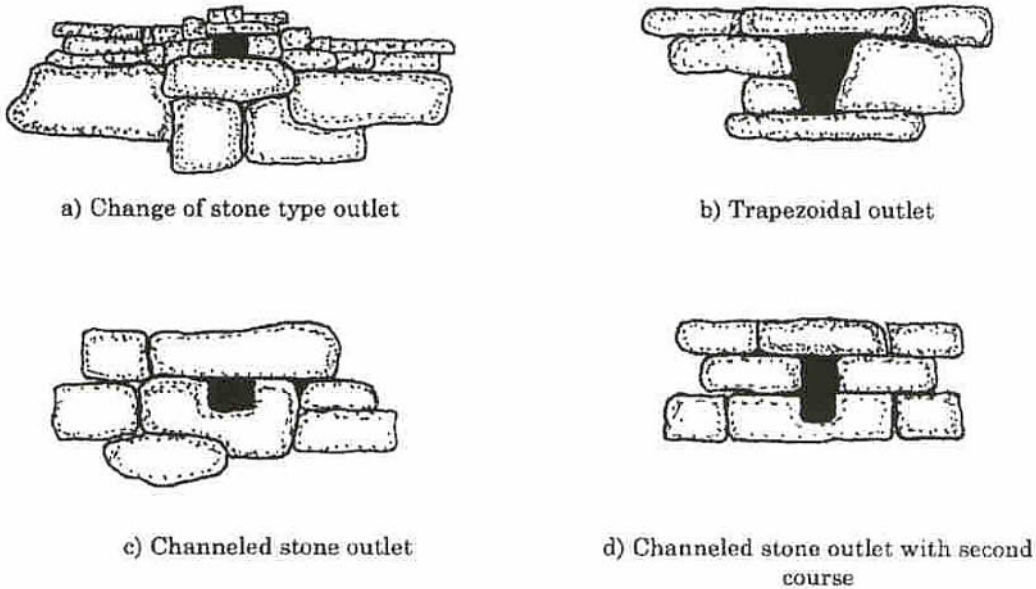
Figure 11. Typical Surface Drain Outlets in Building Walls at Machu Picchu.

The descriptions of the general drainage features and criteria for Machu Picchu provide evidence to support Hiram Bingham's estimate of Inca engineering capabilities. However, the investigation of specific drainage features demonstrates the special care taken by the ancient designers on a site-specific basis. Fig. 11 illustrates details of Inca stone wall drainage outlets at Machu Picchu. Specific facilities are described below.

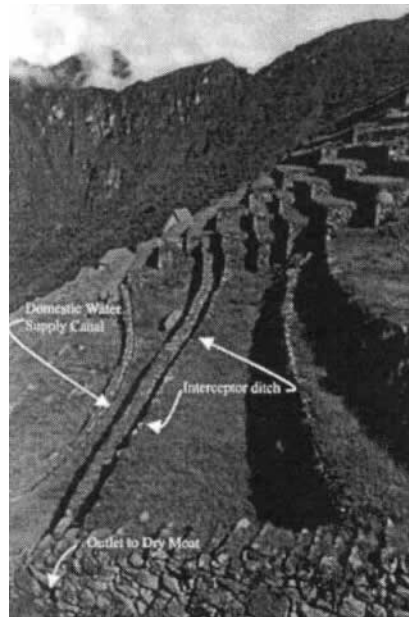
Figure 12. Interceptor Drain Running across Agricultural Sector and Emptying into Dry Moat. Interceptor Drain not only Diverted Surface Water Away from Domestic Water Supply Canal, but also from Troublesome Landslide Area.

A large cross-section interceptor surface drain was constructed from south to north at the base of a long slope and immediately above the domestic water supply canal (Fig. 12). The steep sloping interceptor drain, about 42 m long, terminated at the Main Drain after passing through the south wall of the Main Drain. Much of the uphill slope of this formerly unstable area is void of agricultural terraces, indicating that the builders of Machu Picchu decided not to construct agriculture terraces in the area.

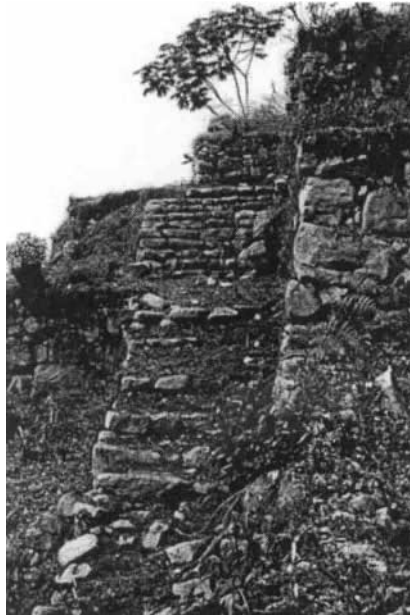
Figure 14. Main Inca Trail from Machu Picchu to Urubamba River Lying Adjacent to Fountains 3, 4, and 5 on Eastern Flank of Ridge.

The 1998 field exploration resulted in more than the excavation of the fountains: a previously unknown Inca trail was discovered. The trail is typically 2 m wide, with many excellent granite staircases ranging up to 3 m wide (Fig. 14). The Inca trail route was followed through the thick rainforest all the way down to the Urubamba River, where the ancient low water crossing was found. The trail is judged by the writers as being the primary trail from Machu Picchu to the easterly Vilcabamba region.
